# GEOMEMBRANES revive Pebble Beach reservoir

## Pebble Beach's Forest Lake Reservoir

# Geotextile TUBES

# GEOSYNTHETICS and Green Roofs

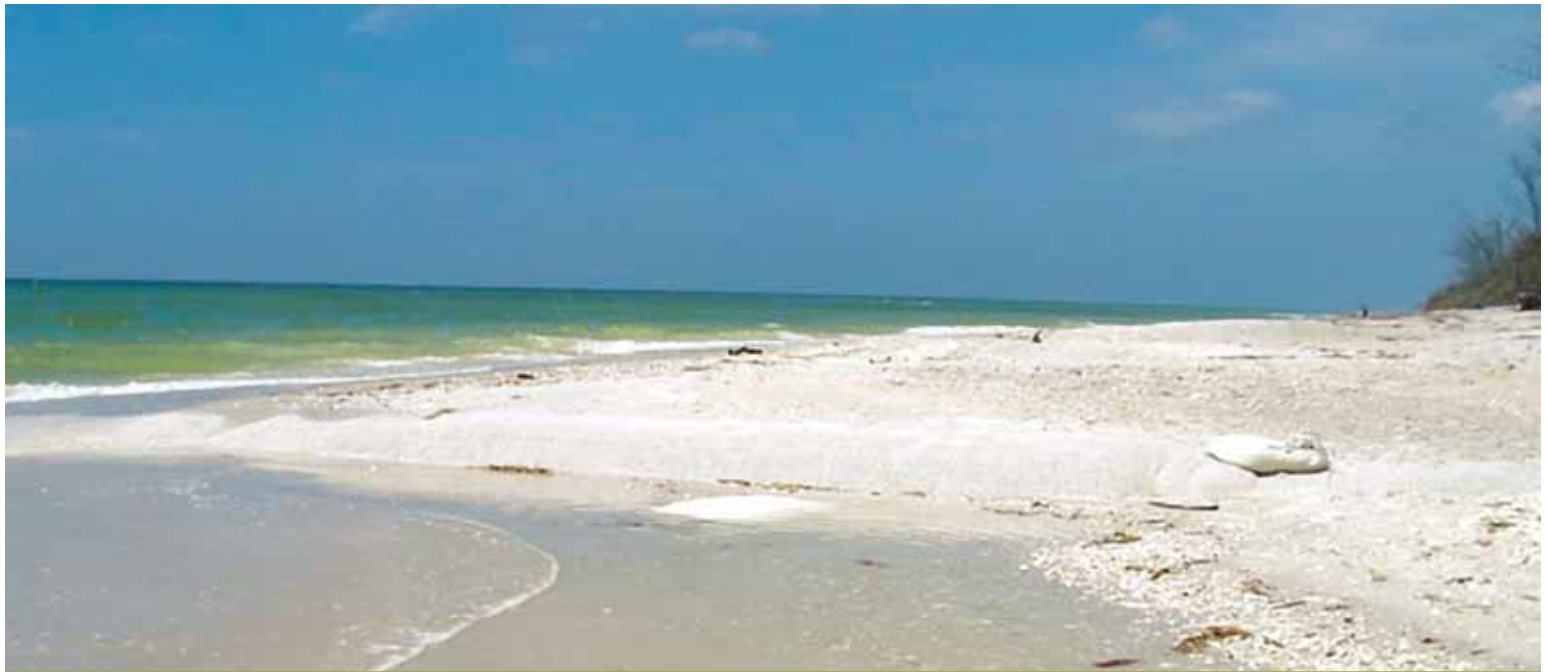
Above: Treated beachfront at Stump Pass after the installation. The experimental system of tubes creates sand-deposit zones and cuts down on cross-shore sand movement. Thus, it slows the rate that Stump Pass channel fills with sand.

To slow the annual rate of sand filling into the channel, the experimental system tubes create sand-deposit zones and reduce cross-shore sand movement. The tubes, which run from the dunes of Stump Pass Beach State Park to a spot 350 ft. into the Gulf, are buried under the beach or submerged under water, so only a portion can be seen. Since June, when three of six tubes were initially installed, 20 ft. of shoreline has been restored.

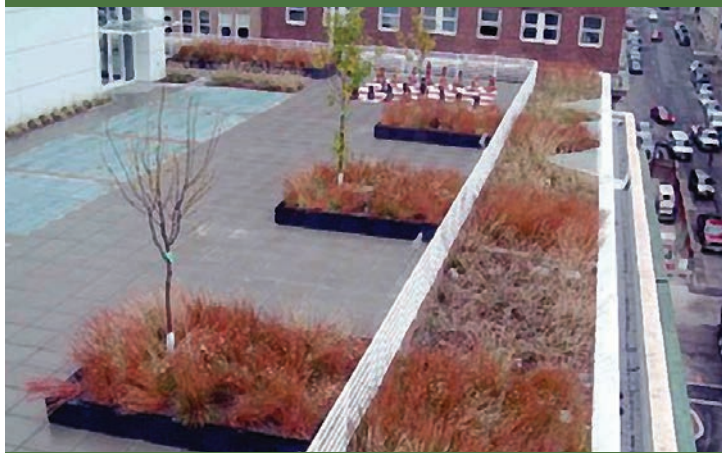
Top: Chicago City Hall: The completed landscape design followed a formal garden plan instead of the more-common meadow environment. The roof, on average, is as much as 30° cooler than the surrounding roofs during the summer. Above: The Kansas City (Mo.) Central Library green roof included triangular skylights between railings.

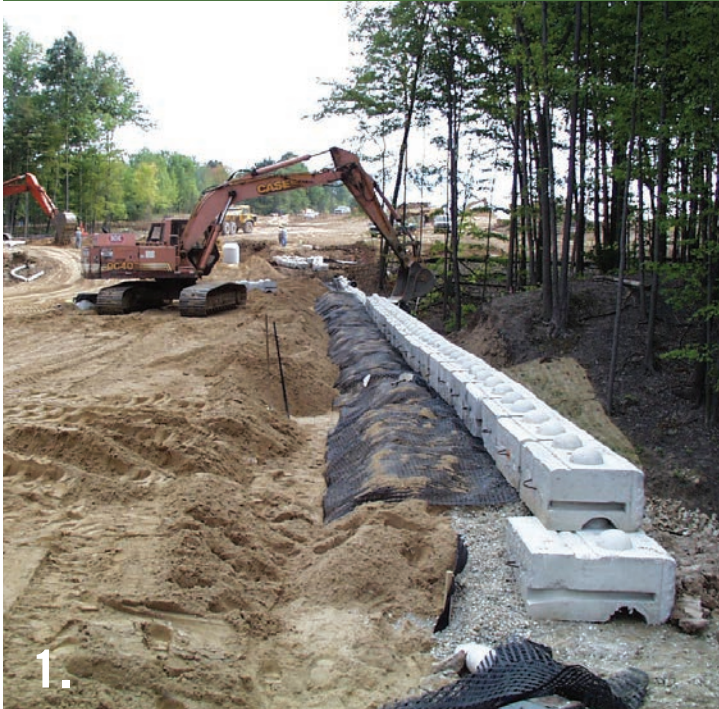
1. Under construction: The retaining wall was designed with looped geogrid placement.
2. Project completed—The finished wall included utilities through it and behind it.

The top four courses, or six feet of the wall, is where the major challenges occurred, as this is where the utilities were tight behind the wall and where geogrid was required. To reinforce the wall and to leave room for utilities, the wall was designed with looped geogrid placement (*Photo 1*).

The layer of grid below the utilities was sized to handle the soil above as a surcharge and the looped grids provided local stability for the wall units and any future excavation for utilities.

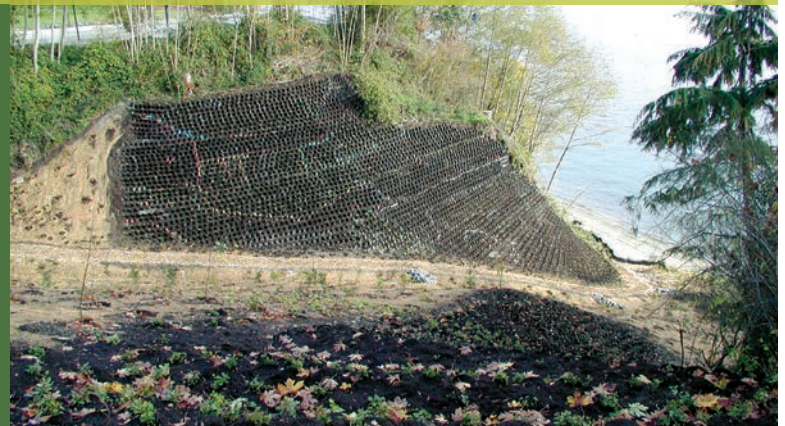
Top Left: Ravine erosion, note sediment trap at ravine mouth Top Right: Geocell placement on steep slope with confined work area Bottom: Completed 30m-high geocell slope

Ravine restoration measures consisted of constructing unreinforced soil, flexible geocell-faced reinforced soil, and geocell-geogrid reinforced soil slopes that mimic the former steep ravine. After slope construction, a mixture of drought tolerant and native vegetation was planted to provide erosion protection and restore the natural ravine environment. The geocells had the flexibility to fit against, and transition between variable slopes and create steep slopes with planting benches for trees, pockets for smaller plants, and terraces that slow storm water runoff. The perforated geocell walls allowed roots to spread. The geocell ravine repair design was an effective, economical solution that saved the customer the cost of potential litigation, satisfied regulatory requirements, and expedited construction, which was completed in less than 5 months during the 2004 construction season.

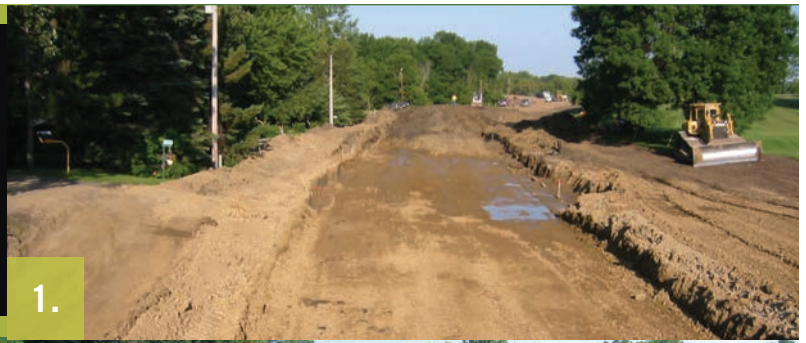
1. The roadbed was removed down to the water table. The material was so saturated that a dozer was unable to track through the area. 2. To drain the area, a perforated polyethylene (PE) pipe drain with sock was selected. 3. Plastic ties and glue were used during the installation process of the drainage sheets. 4. Two feet of fill was placed over the drainage material. 5. For additional stability a geotextile was added 3ft below the profile grade. 6. Roadbed compaction. 7. January 2007, 2 months after completion.

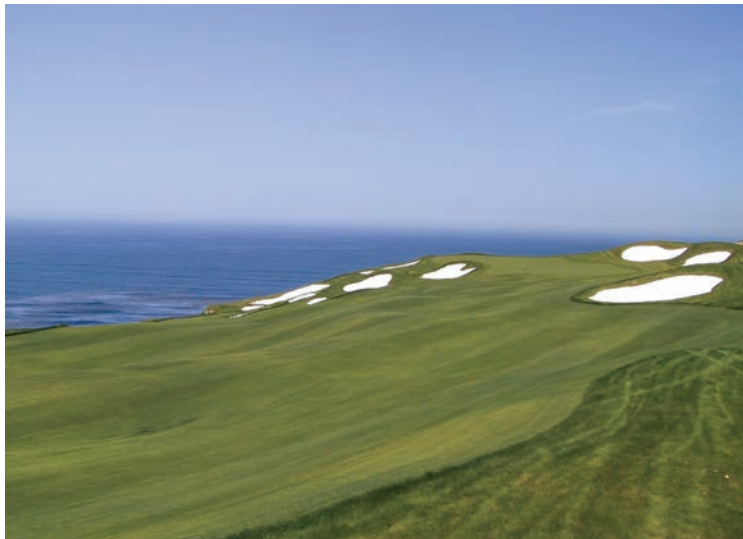
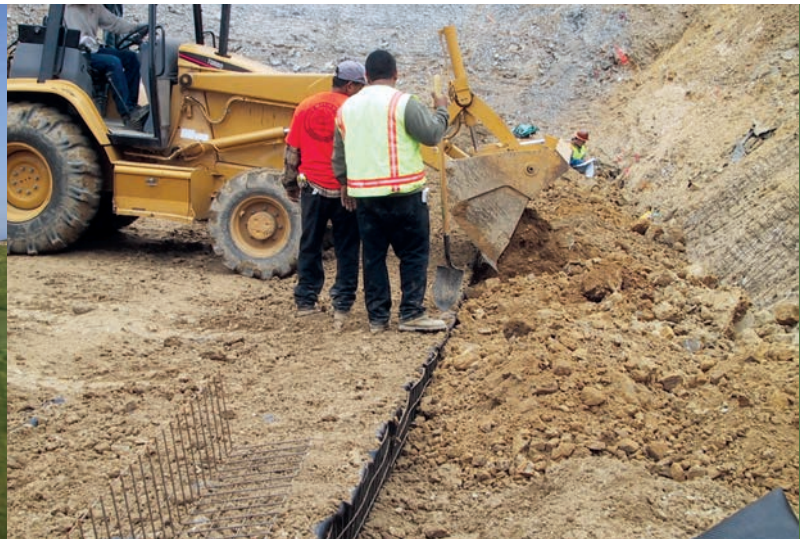
Top Right: A landslide took out most of the 18th hole. The rebuild created a signature hole and a signature geotechnical design. Top Left: Constructing the geosynthetic-reinforced MSE wall buttress.

Partial removal and rebuilding of the landward portion of the landslide was found to be the best alternative for repair using a mechanically stabilized earth (MSE) wall.

Extremely high-strength geotextiles combined with high soil interaction coefficients were essential to the design. Layers of geosynthetic reinforcement were to be placed at approximately 5 ft. vertical intervals with embedment lengths as much as 95 ft. High-strength geotextiles were used as the primary reinforcement to create a massive fabric-wrapped MSE wall buttress (100 ft.+ high). The face of the wall was designed with 18 in. high welded wire forms with a geotextile as secondary reinforcement that would line the interior of the welded forms to contain soil at the face.

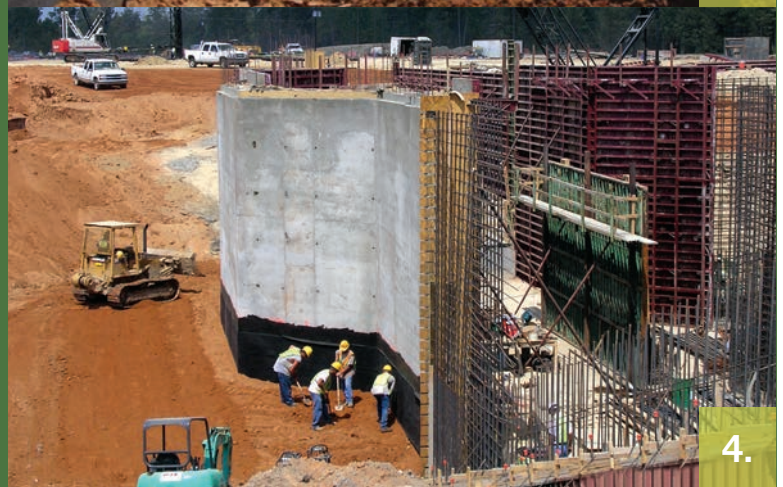
Sheet drain is designed primarily for vertical, one-sided, sub-surface drainage applications requiring an increased compressive strength and a high flow capacity. For this installation, the core side was placed against the wall surface of the foundation, providing full-coverage protection to waterproofing materials (*Photo 2*).

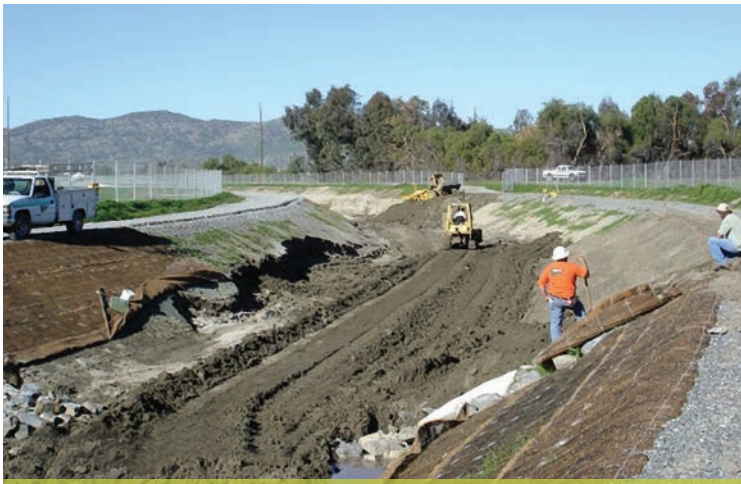
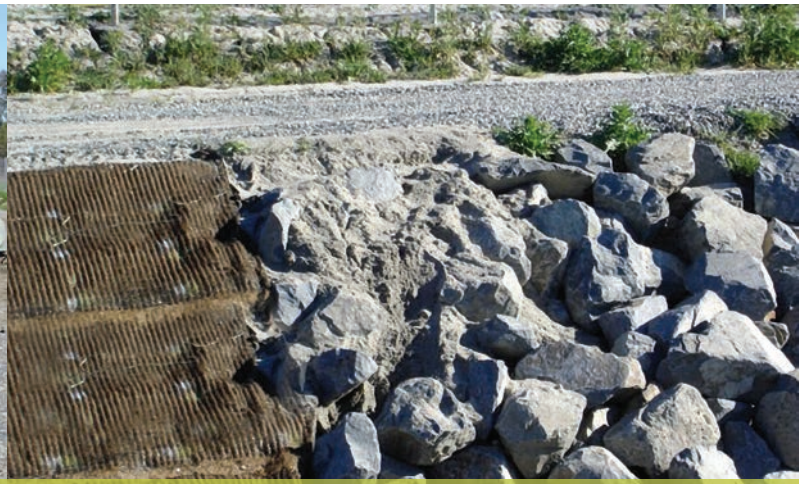
Top Left: Channel during TRM installation—Note protected and unprotected slope conditions.  
Top Right: More rain—Note rock in place failure, with intact TRM. .

The unvegetated installation area was closely monitored for failures during this period. Much to the satisfaction (and relief!) of all concerned, there were no slope or channel-bottom failures where the matting had

been installed; however, the areas that did not have any TRM protection did sustain damage.
